# AIRCRAFT ACCIDENT REPORT

HARD LANDING DURING AUTO-ROTATION

DUE TO IN-FLIGHT ENGINE SHUTDOWN

SW-4, HL9403

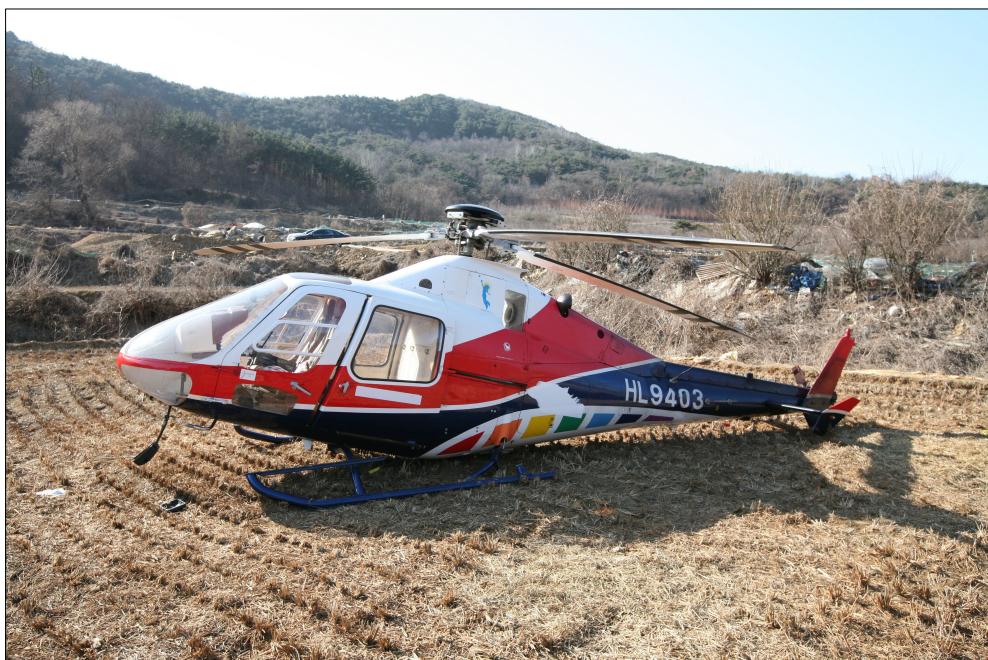
As shown in [Figure 2], HL9403 was destroyed by the crash impact. The HL9403 aircraft was covered under hull insurance<sup>13)</sup>, and pilot and passenger accident insurance<sup>14)</sup>, which were valid at the time of the accident.

[Figure 2] HL9403 Crash due to Hard Landing

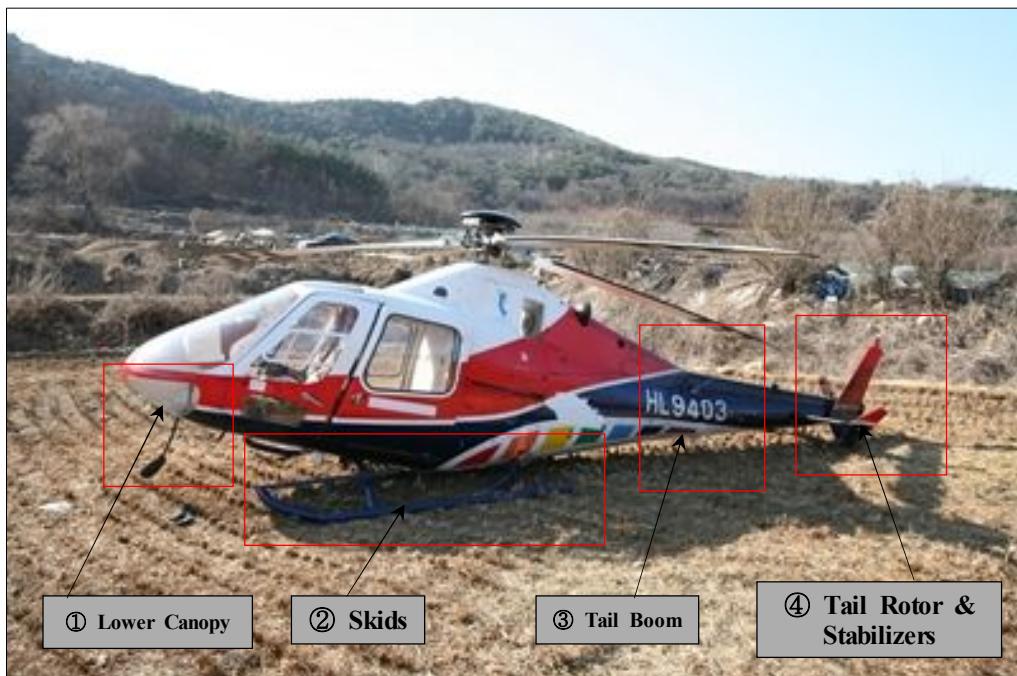
As shown in [Figure 3], there were four major damaged sections of the aircraft, which were examined once on-site immediately after the accident, and twice at the ARAIB's wreckage facility after their placement in custody, one of which was attended by an expert from the manufacturer. The results are described below for each damaged section.

[Figure 3] HL9403 Major Sections of Damage

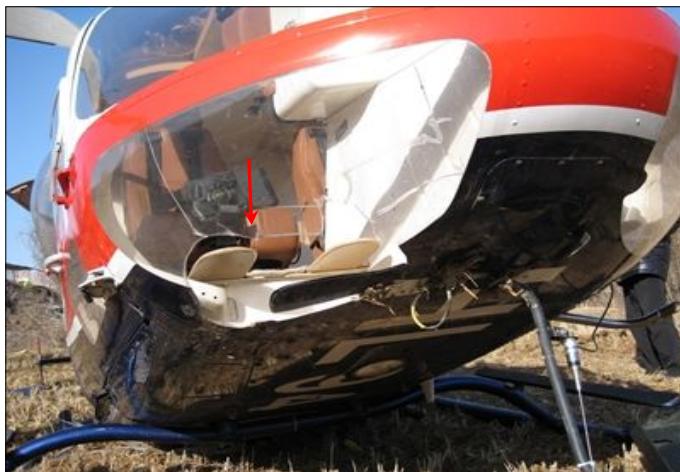
As shown in [Figure 4], the lower right cockpit canopy was shattered by the excessive impact forces which exceeded the stress limits of the skids, when it contacted the ground.

◀ [Figure 4] Damage to Lower Right Canopy (Red Arrow)

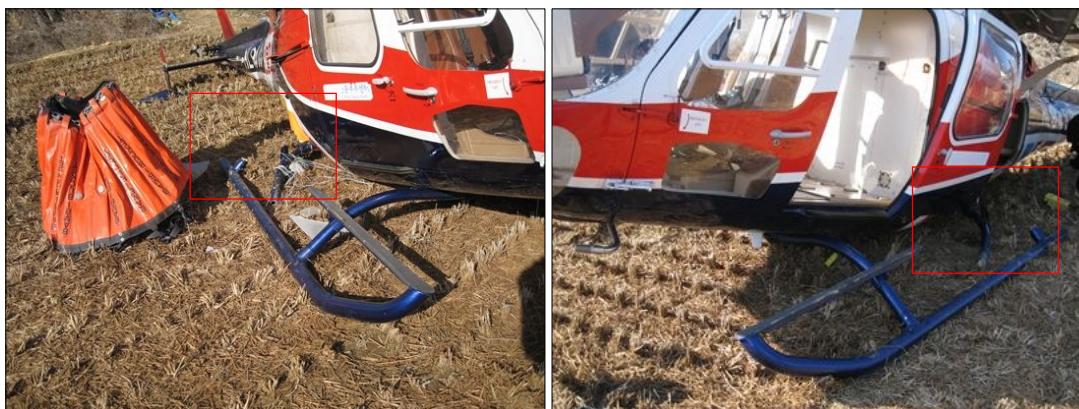
As shown in [Figure 5], the frontal cross-tubes on the skids were bent toward the ground in an "M" shape at the middle, and both the left and right attachments on the rear cross-tubes were detached from the fuselage due to the crash impact.

[Figure 5] Left & Right Side Skid Damage (Red Boxes)

Yet given that HL9403 landed hard in a 180-degree opposite direction from flight, it is determined that the captain failed to properly control the right yaw resulting from the engine failure. Also, given that, as shown in [Figure 5], the Bambi bucket was found beside the right skid of HL9403 during the on-site investigation, with no sign of horizontal movement on the ground, it is determined that the aircraft hit the ground vertically from a height exceeding the length of a bucket tow-line, with no forward momentum.

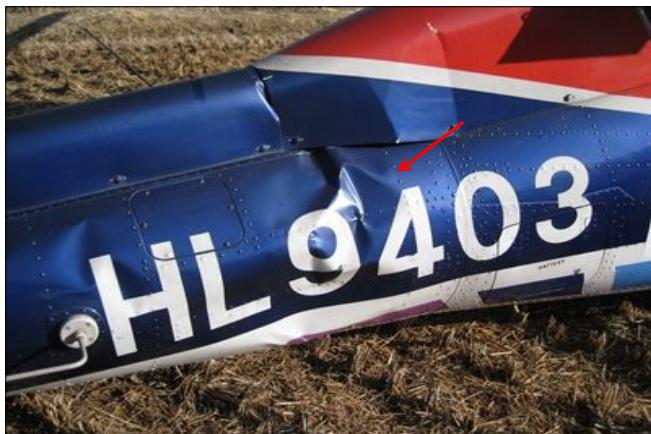
As shown in [Figure 6] the tail boom was bent upward when the vertical stabilizer came into contact with the ground before the fuselage did during the crash, causing a wrinkle on the upper part of it.

◀ [Figure 6] Tail Boom Wrinkle  
Caused When Bent Upward

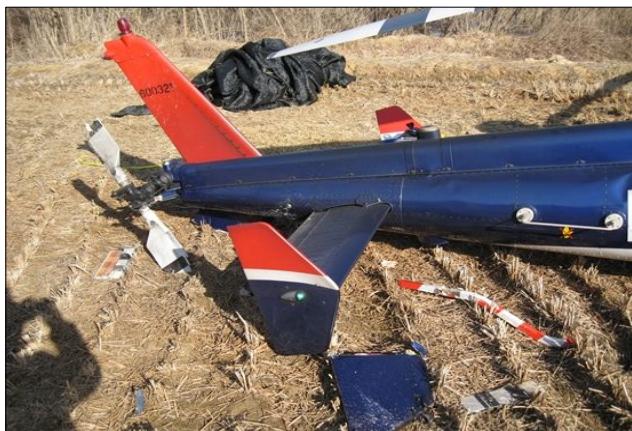
As shown in [Figure 7], both tail rotor blade tips were fractured when they came into contact with the ground, and so were the tail skid and the lower part of the stabilizers.

◀ [Figure 7] Damage to the tail  
rotor, the lower stabilizers and  
the tail skid

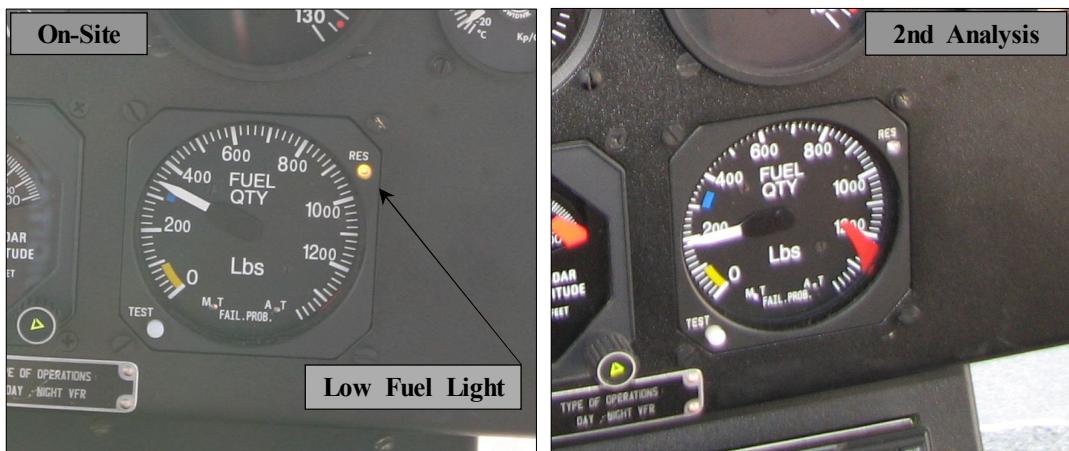
The ARAIB verified, in the on-site investigation, 340 lbs of the remaining fuel on the fuel quantity indicator and the illumination of the low fuel warning light. The second wreckage examination at the ARAIB analysis lab, conducted after the wreckage was placed in custody of the Board, revealed that the remaining fuel reading was reduced to 190 lbs, and when the actual remaining fuel quantity in the tank was checked, it was almost depleted. An investigation into possible fuel leakage or evaporation revealed no such evidence in corroboration.

[Figure 8] Fuel Quantity Indication & Low Fuel Warning Light Illumination  
During On-Site Investigation and the Second Wreckage Examination

12. The on-site investigation revealed that the remaining fuel displayed on the fuel quantity indicator was 340 lbs, whereas the second wreckage examination showed the remaining fuel on the indicator was 190 lbs, and no fuel was found inside the tank when it was checked.

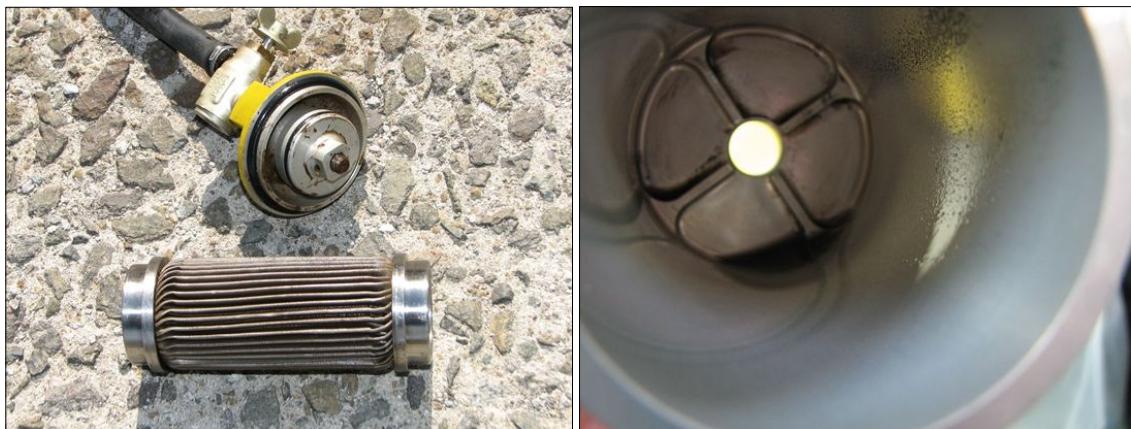
[Figure 9] Fuel Filter and Casing with Contaminated Fuel

The ARAIB conducted a close examination of the engine, from 13 to 15 March 2012, in Samsung Techwin<sup>36)</sup> Factory #2 located in Changwon, Gyeongsangnam-do, in the presence of specialists from the airframe and powerplant manufacturers, and Samsung Techwin. As a result, it was confirmed that ① all engine functions were normal, and that ② the fuel pump and filter were excessively contaminated. Please, refer to [Figure 9].

Accordingly, given that ① HL9403 had been operated a total of only 11 hours for approximately two years since the delivery, and preservation maintenance had been mainly performed, and that ② since the purchase by the YASC, it had accumulated short operation hours compared to other aircraft, the ARAIB determines the cause of the fuel system contamination as follows: contaminants ingested into the tank during preservation maintenance or flight had settled at the bottom due to the low circulation rate of the fuel inside the tank, then as the fuel was depleted, the contaminants were ingested into the pump.
