# **Aircraft Accident Investigation Report**

**Karnali Air Pvt. Ltd.**

**9N-AGS MI-17 IV Helicopter**

**on 08 August 2006**

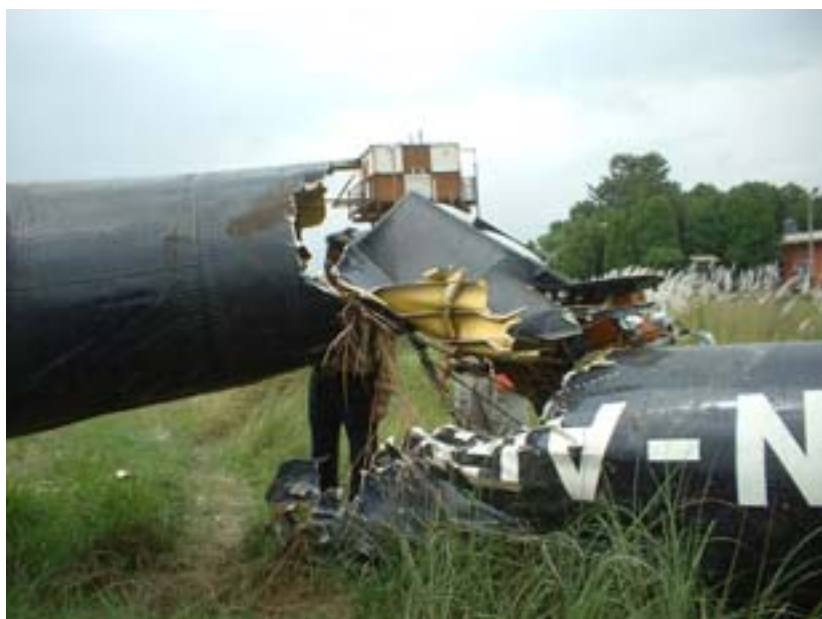
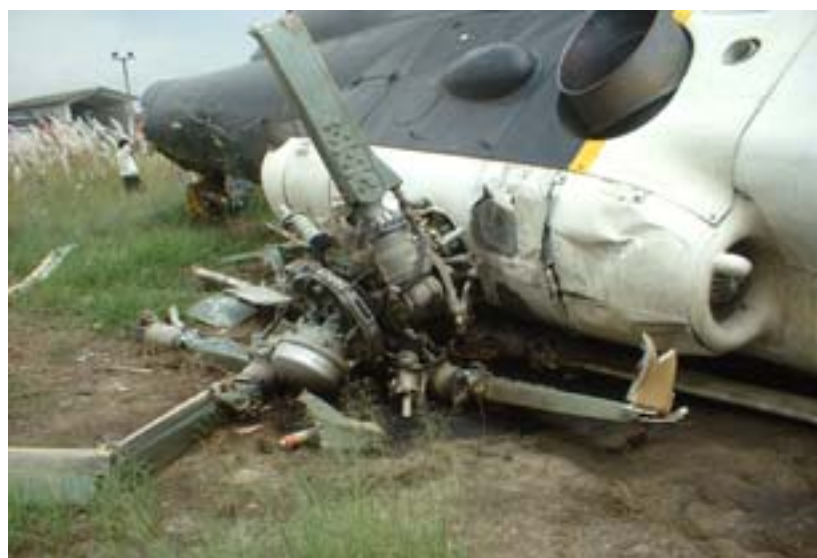
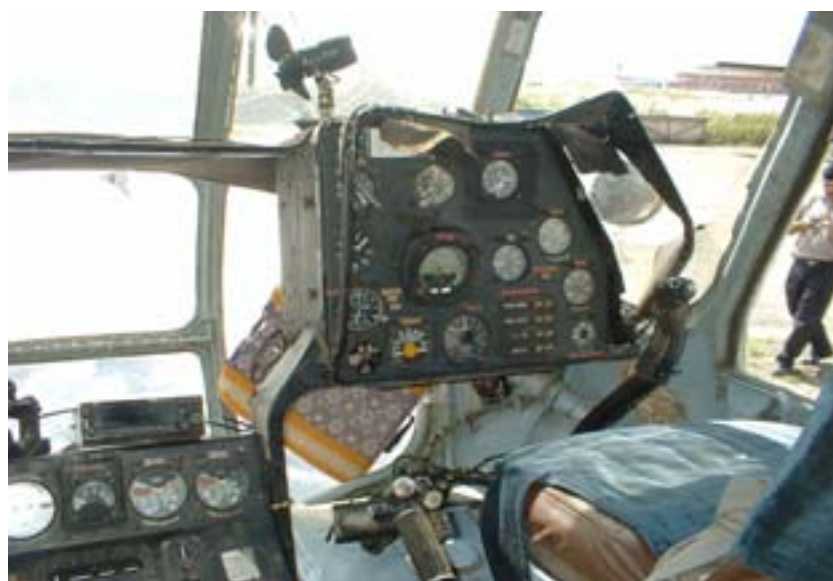
## APPENDIX-C

- a. Central fuselage section was damaged
- b. The main rotor blades were broken into pieces and scattered around the accident site.
- c. Main rotor head was damaged.

- d. Tail boom was detached at the attachment point from the fuselage section.
- e. Vibration damper detached.
- f. Swash plates, hydraulic boosters were damaged.

- g. Tail rotor drive shaft was decoupled & bearing supports were damaged.
- h. Horizontal stabilizers were damaged.
- i. Tail bumper was detached.
- j. Pylon was twisted and damaged

- k. Tail gear box was damaged.
- l. Tail rotor head was damaged and tail rotor blades broken into pieces and was found scattered.
- m. Intermediate gearbox was damaged.

- n. Electrical instrument panels have some minor damage.
- o. Kerosene heater (KO-50) was damaged.
- p. Some electrical units were detached from their mounting.

- q. Main gearbox was damaged.
- r. Rear Cargo door was damaged.
- s. Windshield and blisters were damaged.
- t. Fuel tanks damaged and there was fuel and oil spillage.

- v. No sign of Foreign Object Damage (FOD) inside the engine intakes was found. First stage compressor blades of both engines appeared intact.
- x. Turbine blades appeared intact.

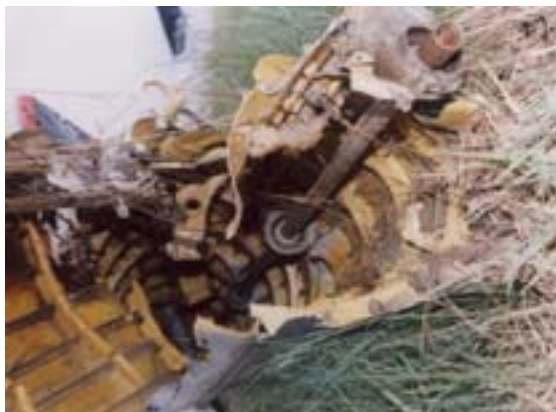
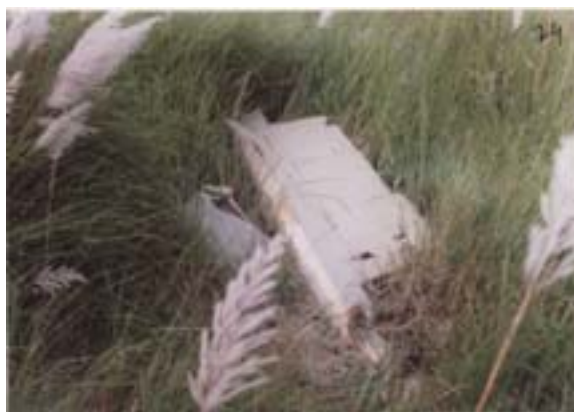
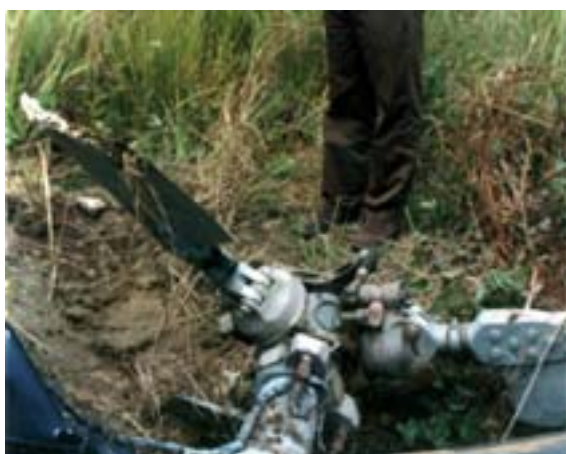
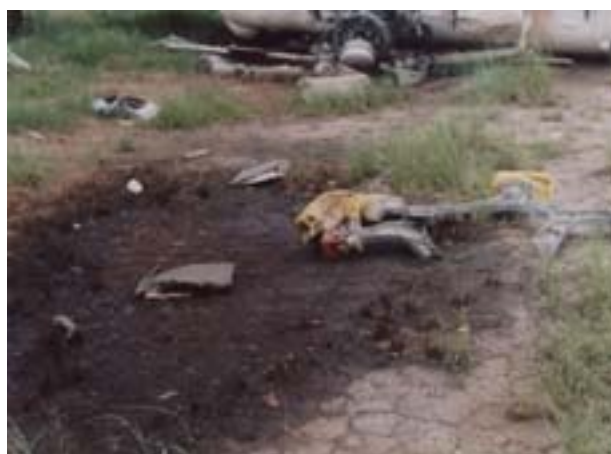
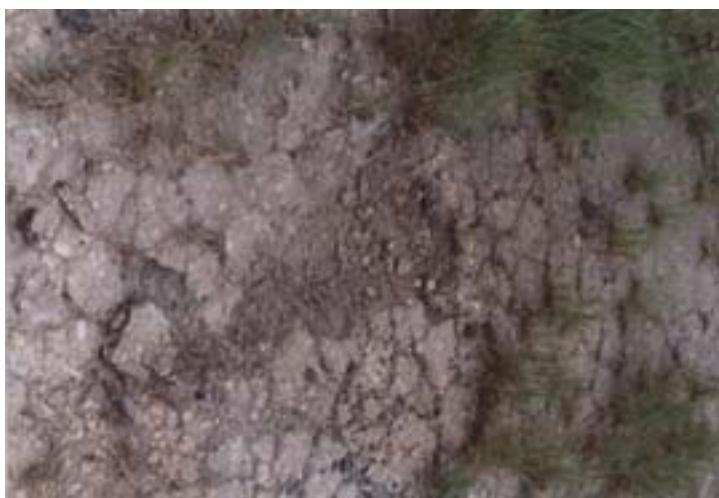
## APPENDIX-J

The Commission members visited the site in order to collect the available evidences and the information regarding the accident on 06 September, 2006 from available witnesses. Observation showed that the first impact was on paved area and the helicopter swung about 270<sup>0</sup> before toppling on its right side facing west. The wreckage and pieces that were scattered over the area had been removed to prevent foreign object damage (FOD) to other aircraft. There were signs of fuel spillage from the helicopter at the site. Assessment of the helicopter and the site indicated that the damage incurred by the helicopter was post impact.
