# AIRCRAFT ACCIDENT REPORT

HARD LANDING DURING AUTO-ROTATION

DUE TO IN-FLIGHT ENGINE SHUTDOWN

SW-4, HL9403

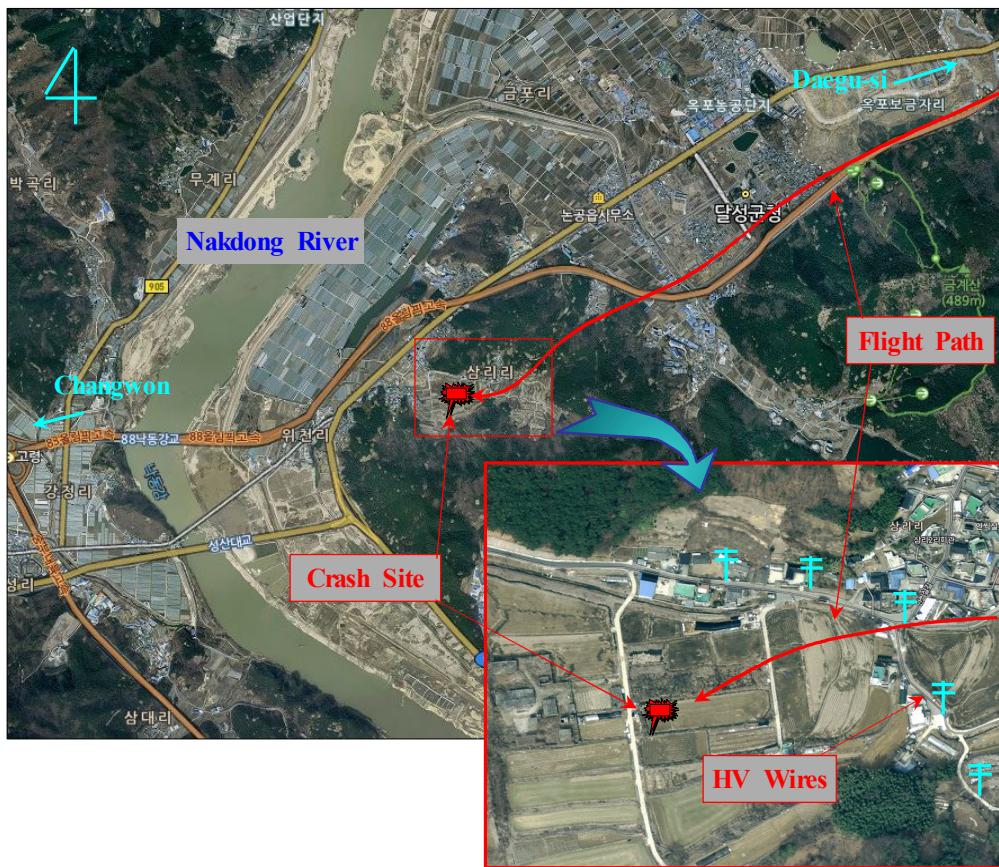
[Figure 1] Flight Path & Crash Site

Thereafter, the captain waited at the ready room<sup>10)</sup> and finished lunch, and about 14:10 reported his departure by telephone to the Daegu Airport branch office. He started HL9403 about 14:15 from the left seat and took off about 14:18 from the staging field, proceeded to Daegu-si Dalseong-gun's Habin-myeon and Dasa-myeon areas and completed his forest fire patrol flight with prevention broadcasts, and while returning to the staging field, landed hard at the crash site approximately 14:50<sup>11)</sup> as shown in [Figure 1].

Upon arrival at the scene of the accident, the captain was flying at a speed of 70-80 kts, at an altitude of 150-200 ft AGL. Over the crash site, warning lights illuminated and warning horns sounded with change to the engine noise, and the aircraft yawed to the right as N1 and N2 indications decreased.

The captain judged the situation to be an engine failure and attempted an emergency landing (auto-rotation) over the accident site. During the maneuver, the captain was concerned that his Bambi bucket might be caught in power line wires<sup>12)</sup> located before the anticipated touch-down point and pulled back slightly on the cyclic to fly over the wires, but as he failed to maintain aircraft pitch and descended, the aircraft continued to rotate to the right and landed hard on a paddy field in a 180-degree opposite direction from flight.

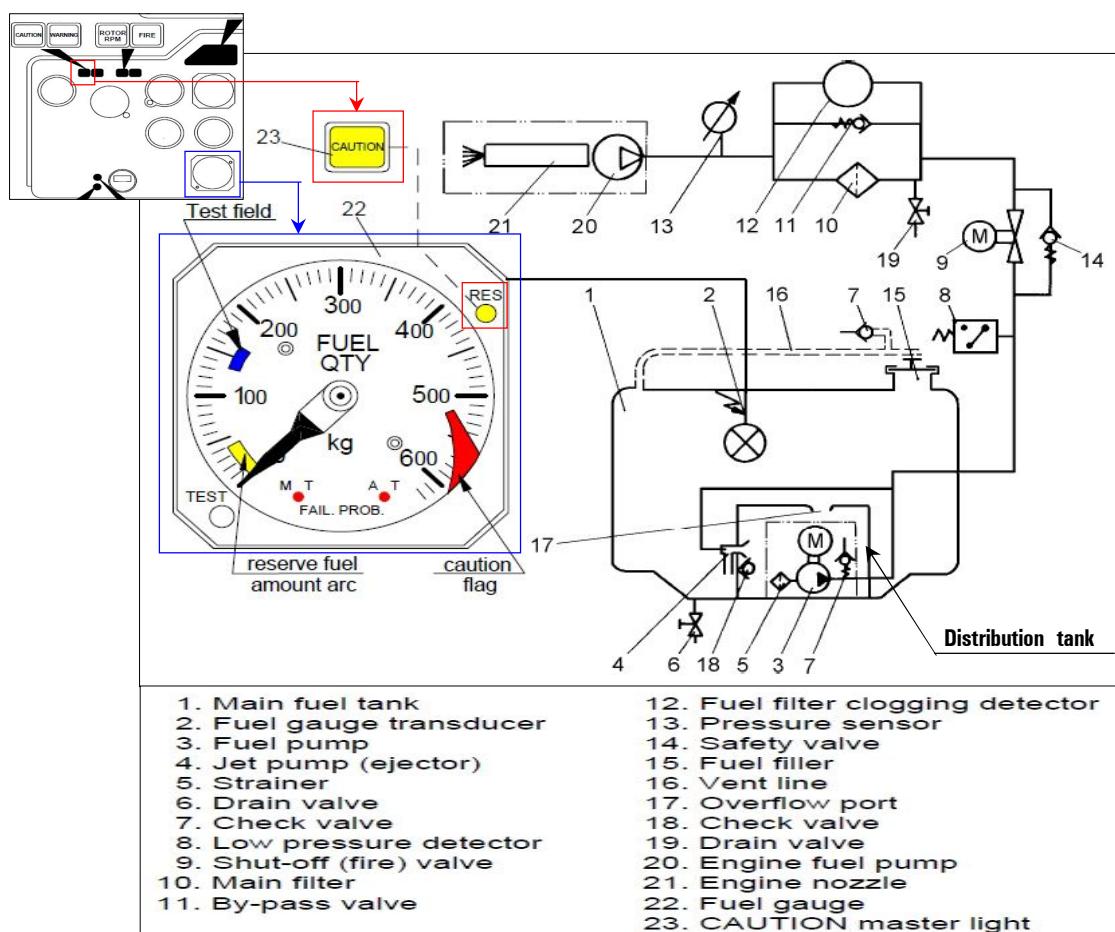
[Figure 11] Fuel System of HL9403 (fuel quantity Indicator, denominated in lbs)

As shown in [Figure 11], the fuel tank of SW-4 consists of the main fuel tank (1) and the distribution tank, which is inside the main fuel tank. Fuel injected through the fuel filler (15) is fed into the distribution tank through the overflow port (17) at the top of the distribution tank and through the ejector (4).
