# **Aircraft Accident Investigation Report**

**Karnali Air Pvt. Ltd.**

**9N-AGS MI-17 IV Helicopter**

**on 08 August 2006**

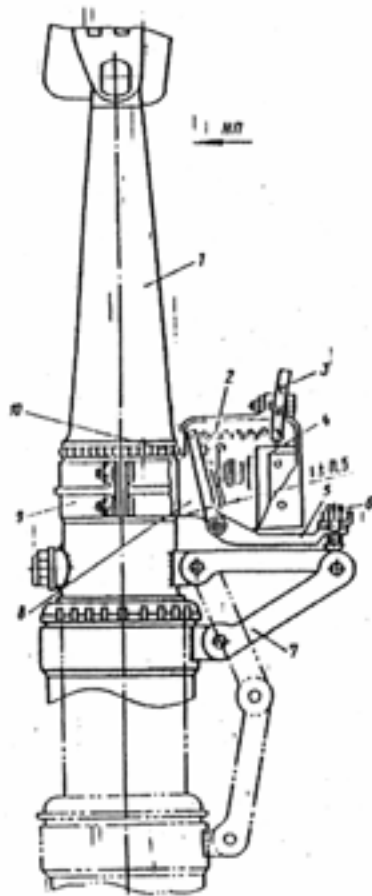
When the strut is not compressed and the upper section of the torque link is separated from the pusher, the rocker upper arm, under the action of the spring, presses

on the micro switch rod, the micro switch operates and through respective contacts cuts out the hydraulic stop system.

Fig. . Mechanism for switching-on hydraulic stop

1. Shock strut of main landing gear
2. Spring
3. Wire cable
4. Microswitch AM-600K
5. Rocker
6. Pusher
7. Splined joint
8. Detachable block
9. Clip
10. Port for measuring the gap of microswitch
